# Healthy Mangroves

# Calls for Action

# Long-Term Field Observations - Barwon Estuary (2019–2026)

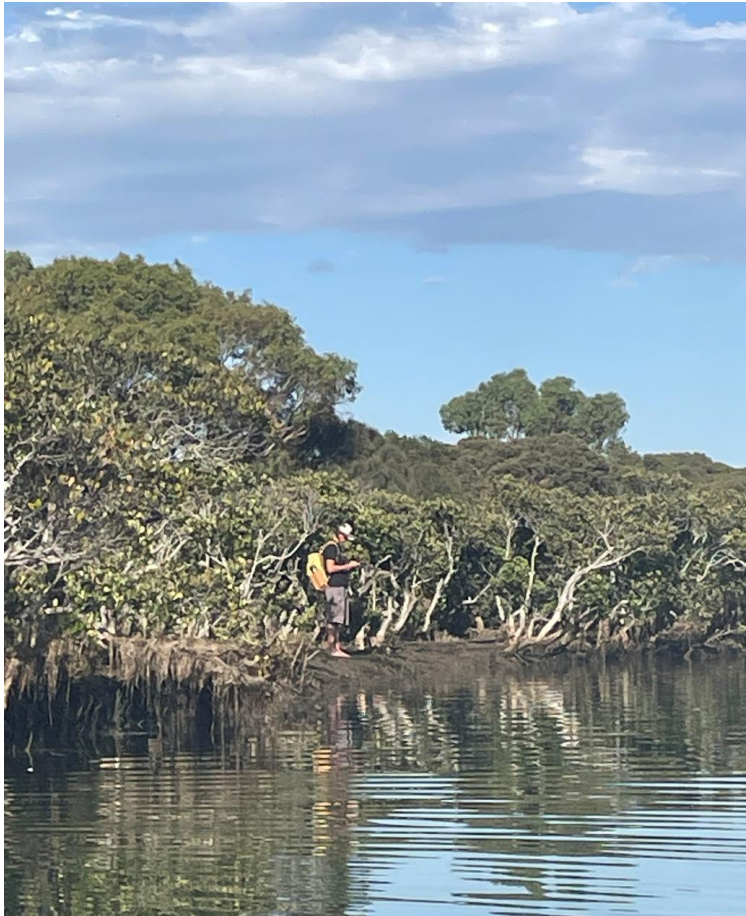
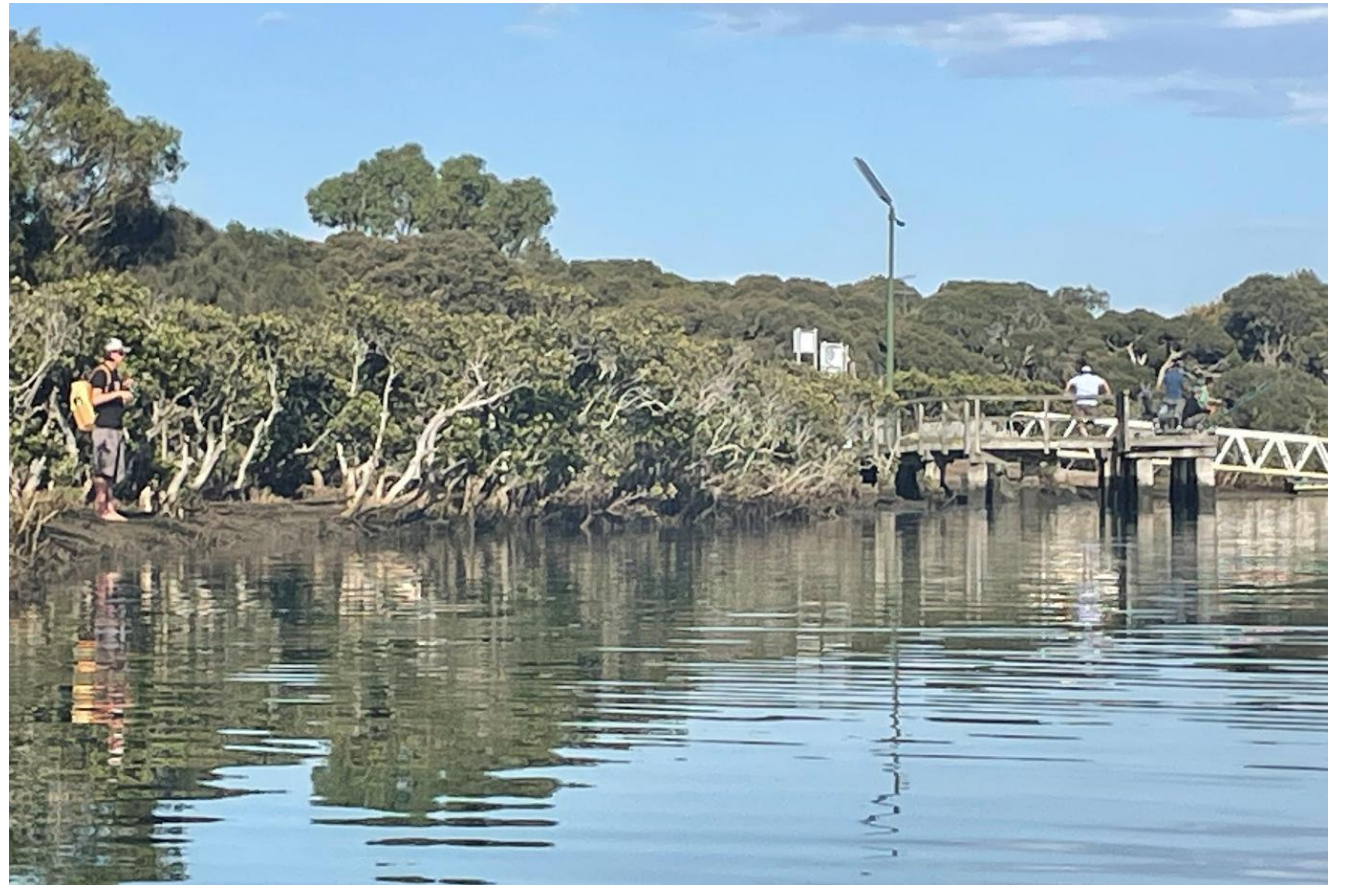
## Recreational Fishing in the Mangrove Habitat

Recreational fishing activity observed within the mangrove zone, with foot traffic on exposed mangrove root systems.

- Support Parks Victoria's initiatives — the proposed mangrove boardwalk at Barwon Heads, including designated fishing platforms to reduce trampling of mangrove roots, and the survey of the Ocean Grove Golf Club to inform measures addressing water discharge, nutrient runoff and appropriate vegetated buffers along the estuary.
- Enhance drainage infrastructure by supporting collaboration with the City of Greater Geelong to improve water quality as drainage systems are upgraded for climate adaptation.
- Invest in science and monitoring by funding dedicated mangrove expertise, developing a Barwon Estuary Mangrove Management Strategy, and supporting a MangroveWatch citizen science monitoring programme for the estuary.

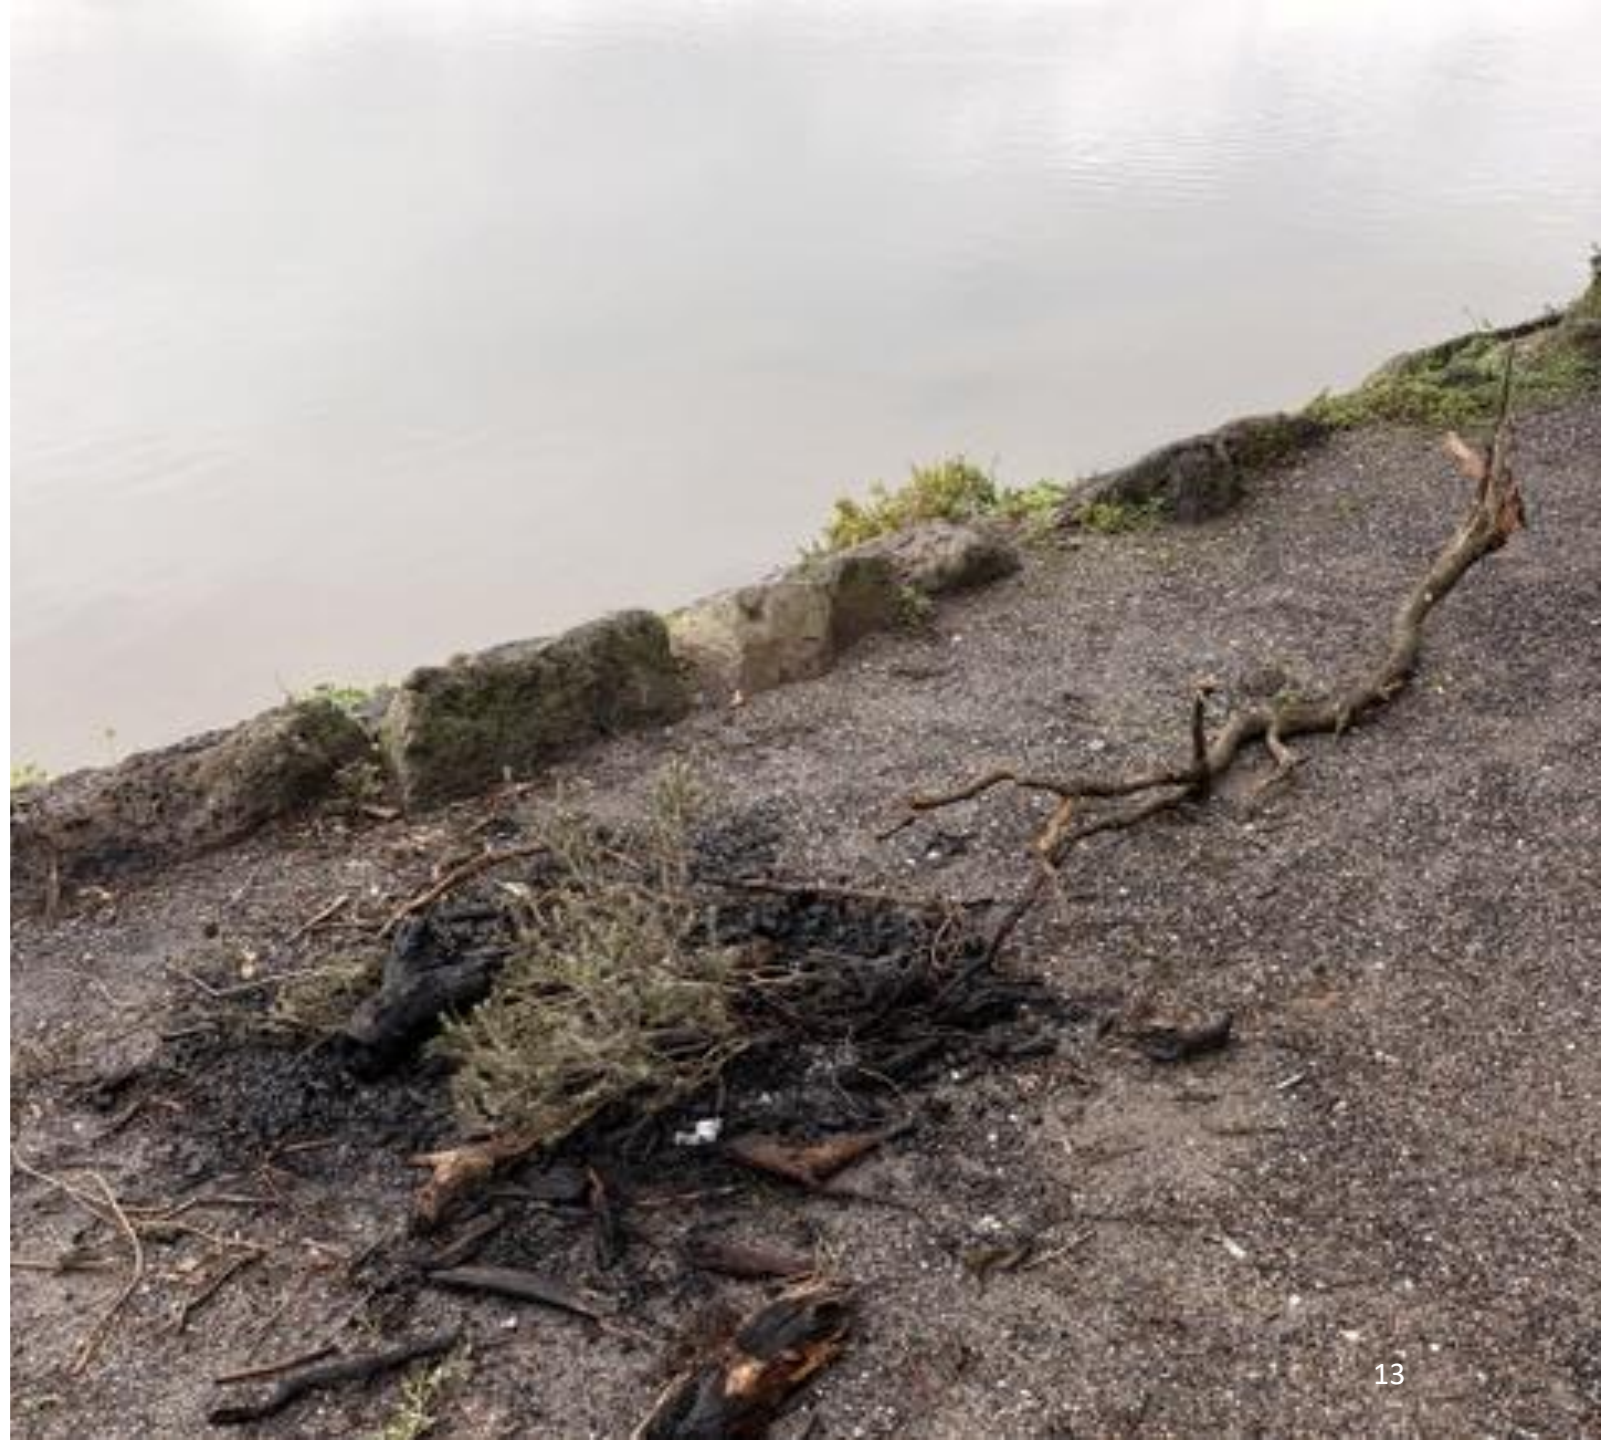
Evidence of fishing and cooking activities along the water's edge of the Barwon Estuary, including burnt vegetation and disturbed shoreline, illustrating visible human impacts on the estuarine environment.

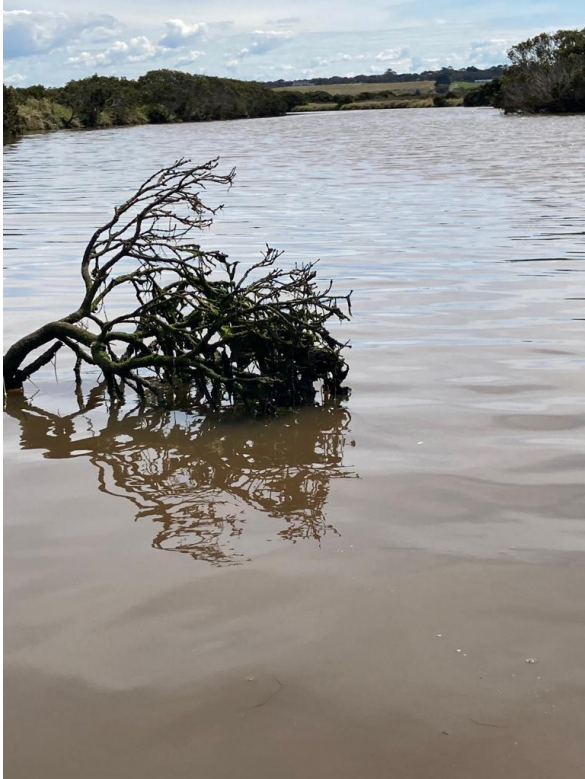
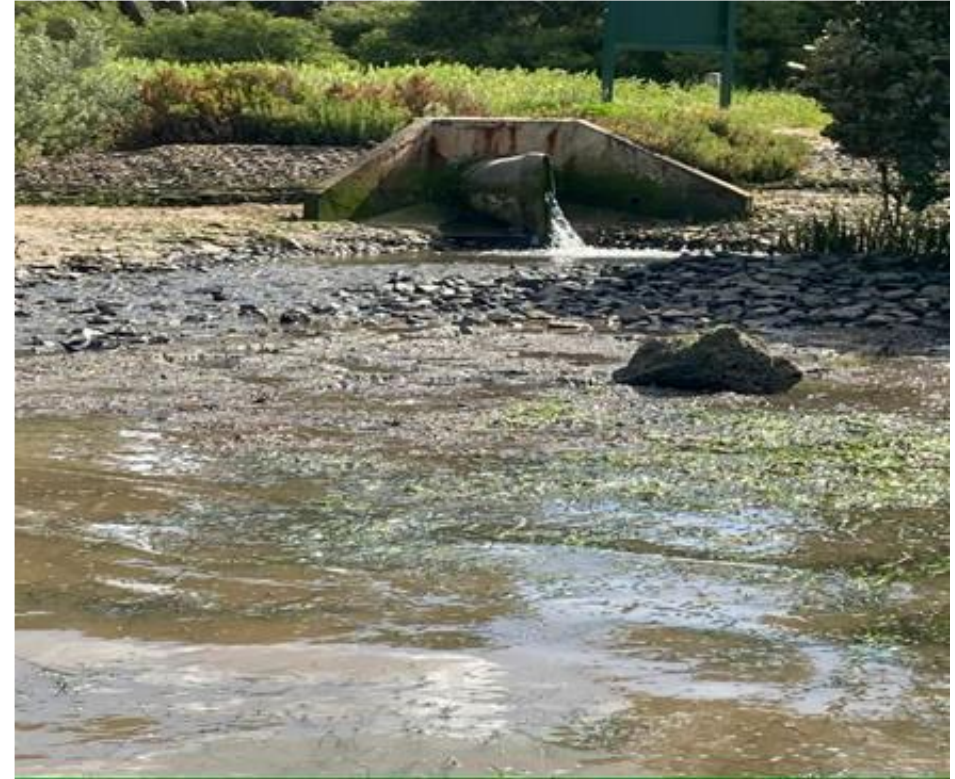
- Regular water discharge into the estuary.

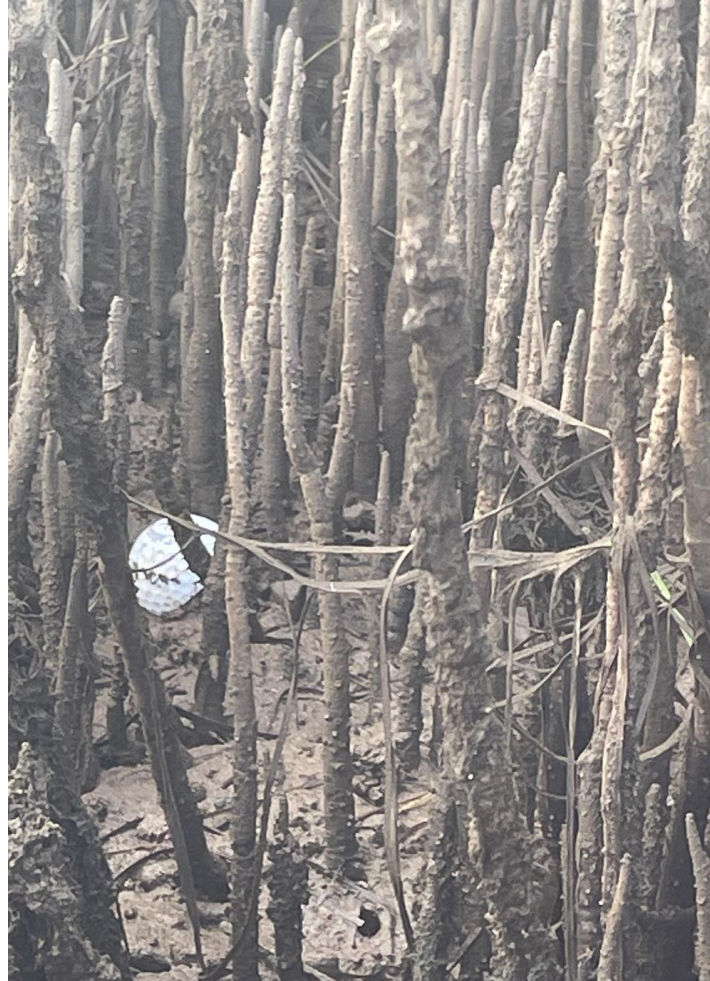
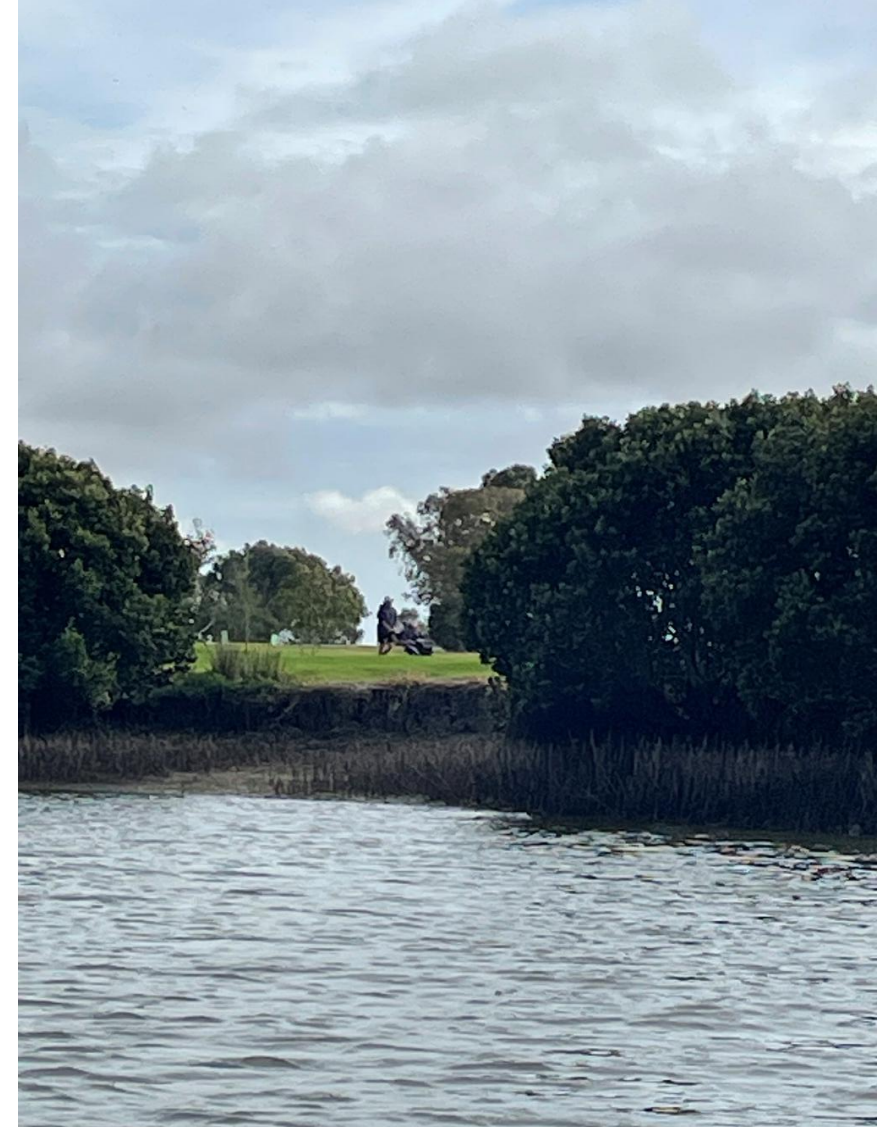
# Ocean Grove Golf Club

Parks Victoria and CCMA have identified water discharge from the Ocean Grove Golf Club and turf extending unlawfully to the estuary's edge, raising concerns about impacts on the adjacent mangrove ecosystem.

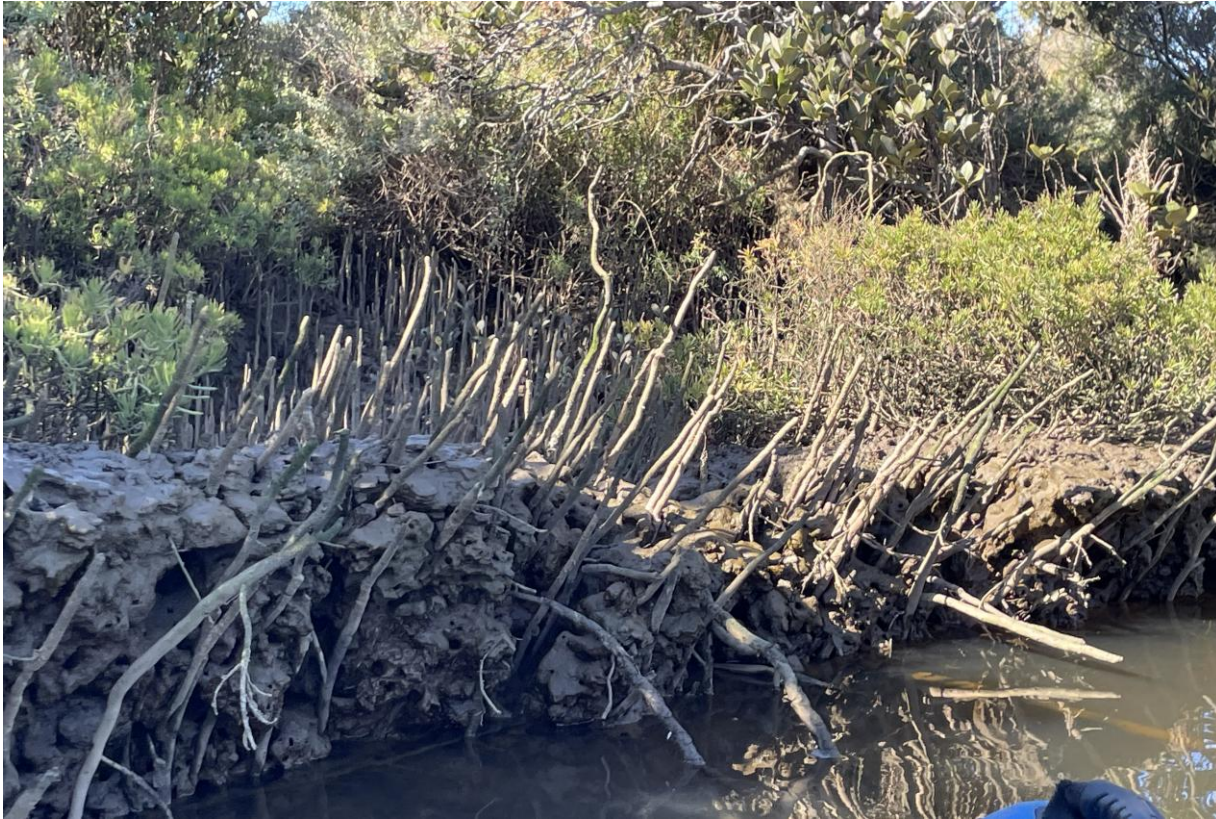
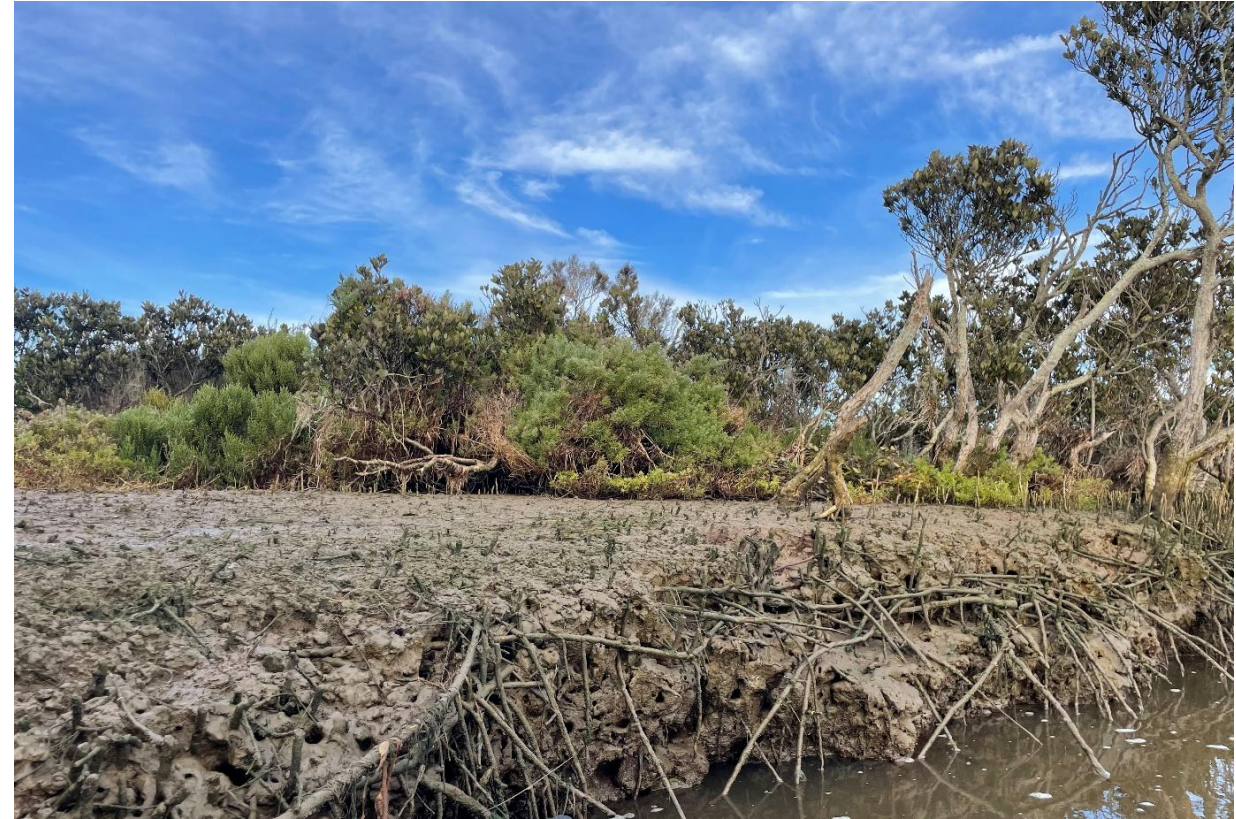
# Riverbank Erosion

- **Riverbank erosion:** Areas of erosion, saturated mud, and mangroves affected by wax scale are evident, particularly along the river margin adjacent to the Ocean Grove Golf Club.

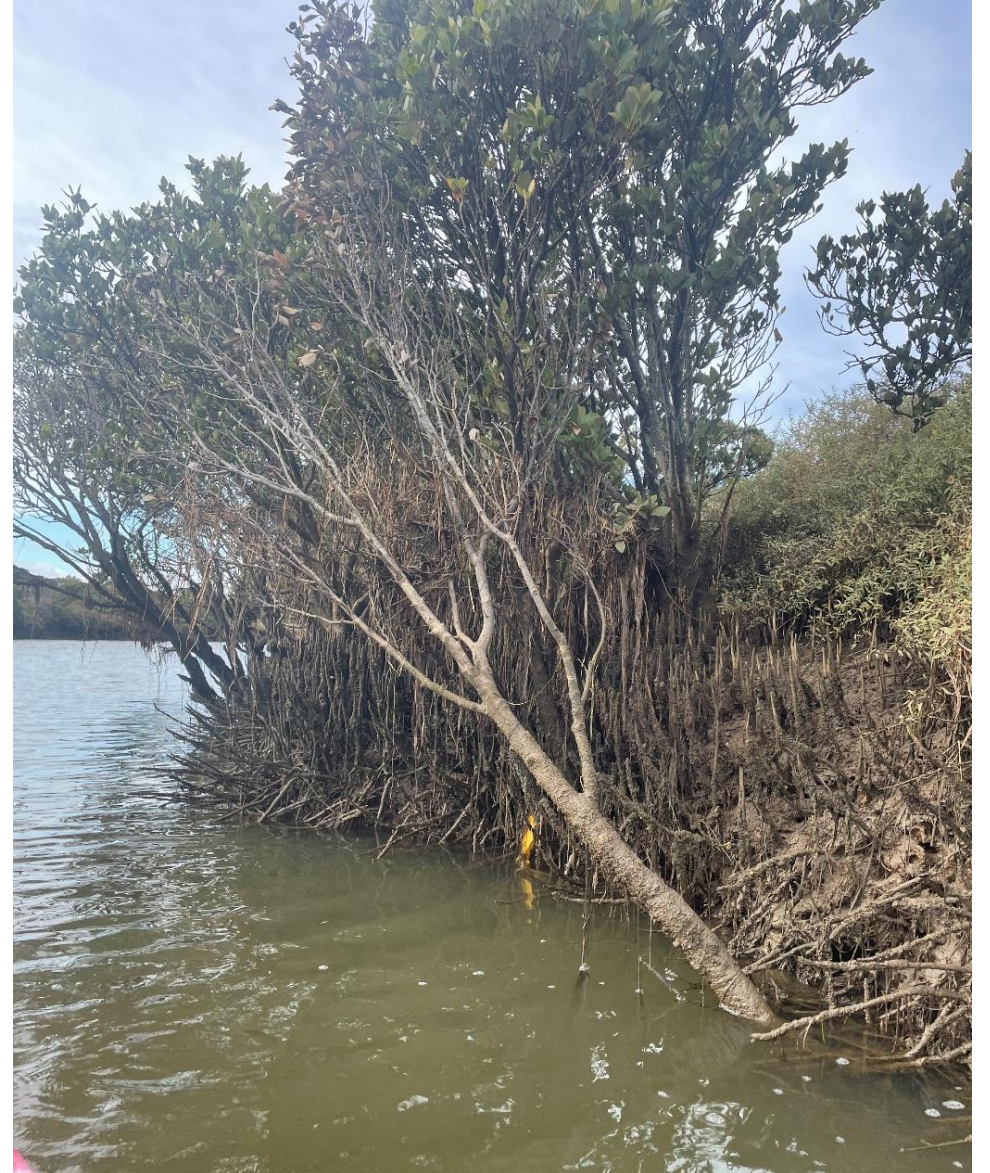
# Riverbank Tree Collapse

A collapsed tree along the Barwon Estuary, illustrating riverbank instability and the need for ongoing monitoring and restoration of vulnerable shoreline areas.

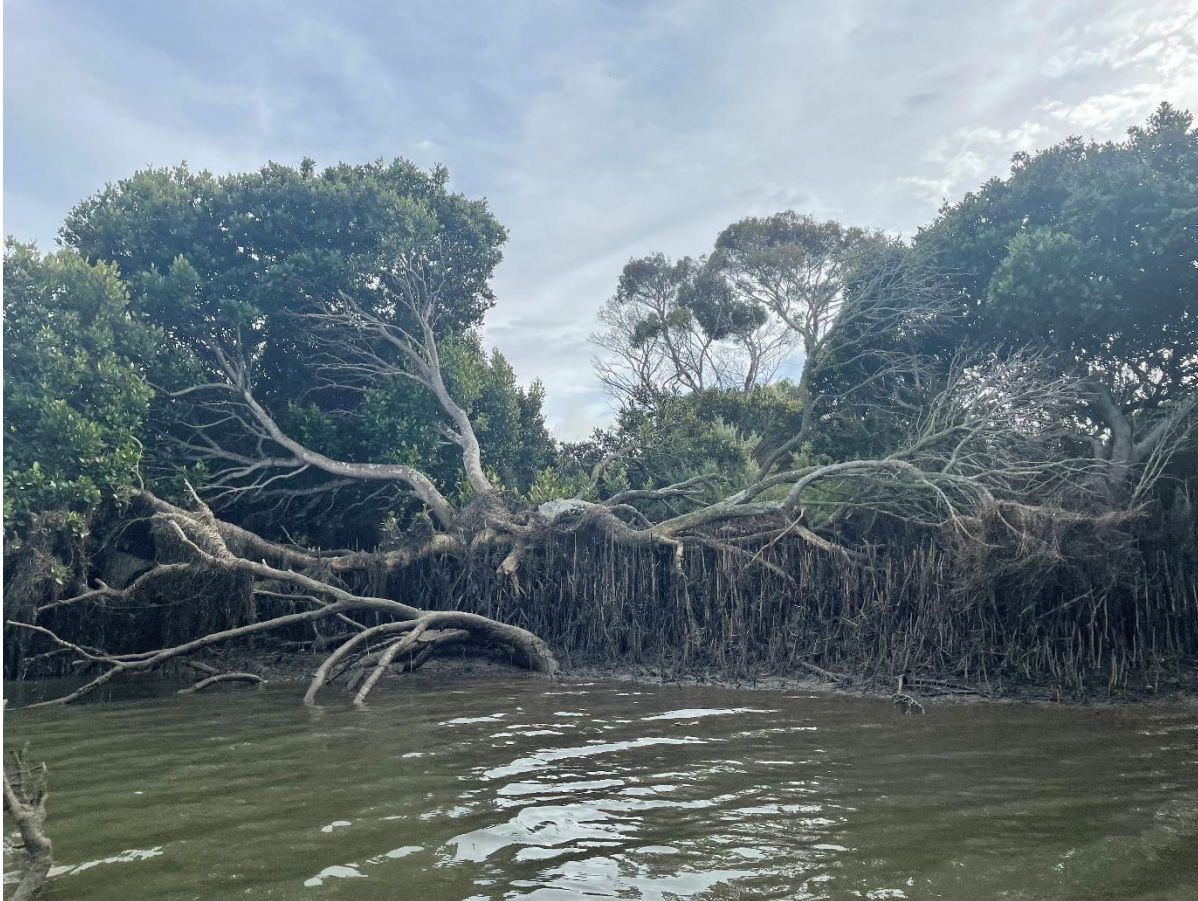
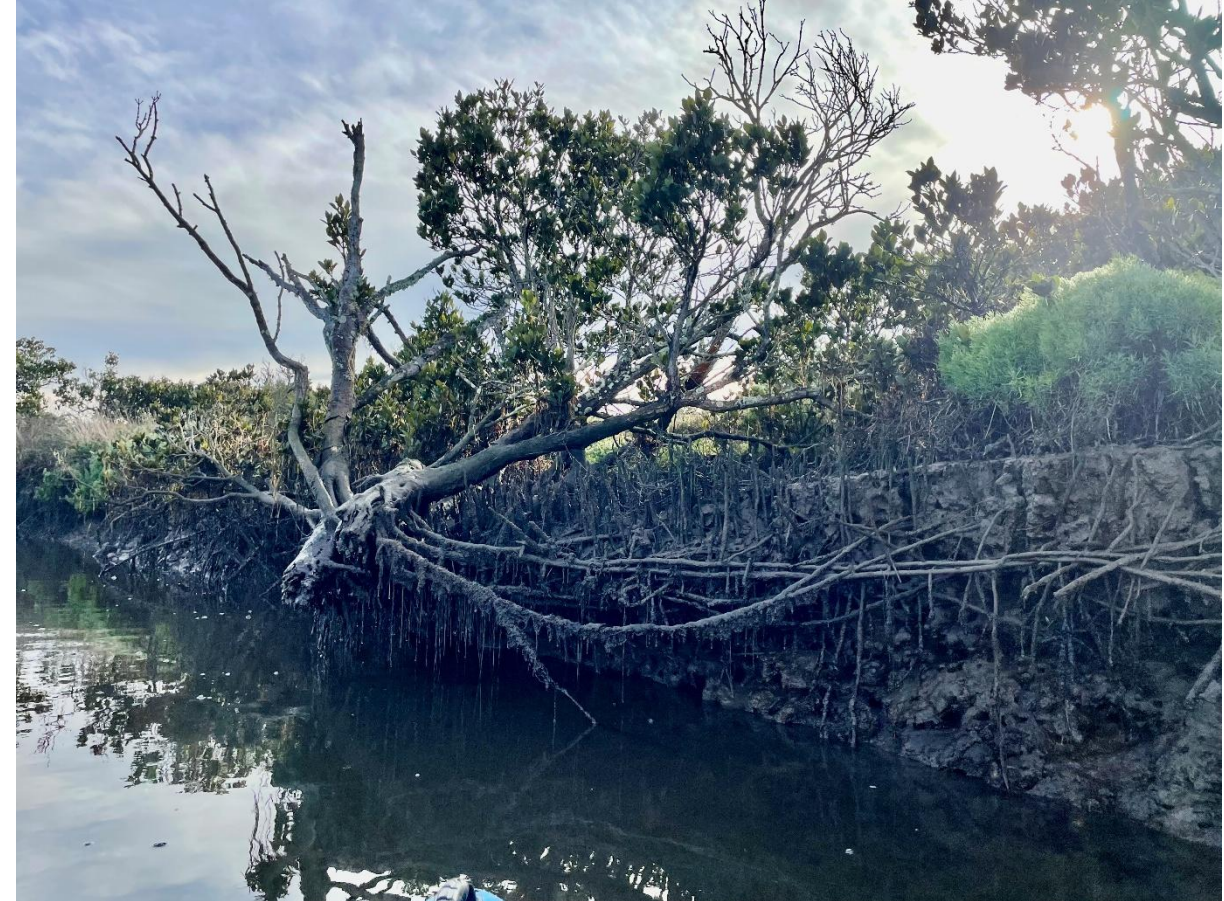
# Mangrove Decline

Collapsed mangrove observed along the river margin adjacent to the Ocean Grove Golf Club, illustrating the urgent need of ecological assessment and collaborative management of this section of the estuary.

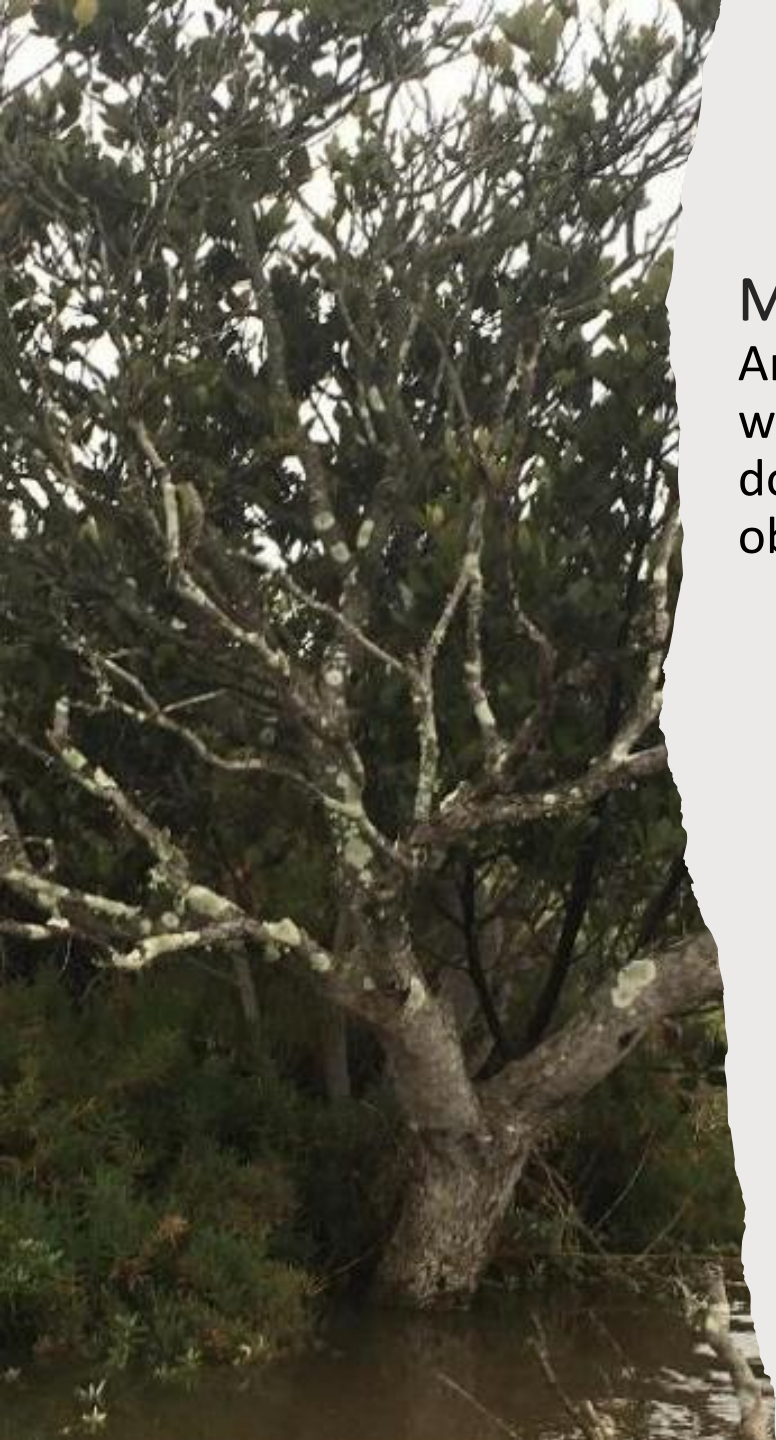
## Mangrove Decline

Areas of mangrove decline associated with wax scale infestation, documented during ongoing field observations of the Barwon Estuary.

Wax scales are sap-sucking insects that produce a waxy coating, often associated with environmental stressors such as changes in salinity, pollution, or climatic shifts. These stressors can weaken mangroves, making them more susceptible to infestations.

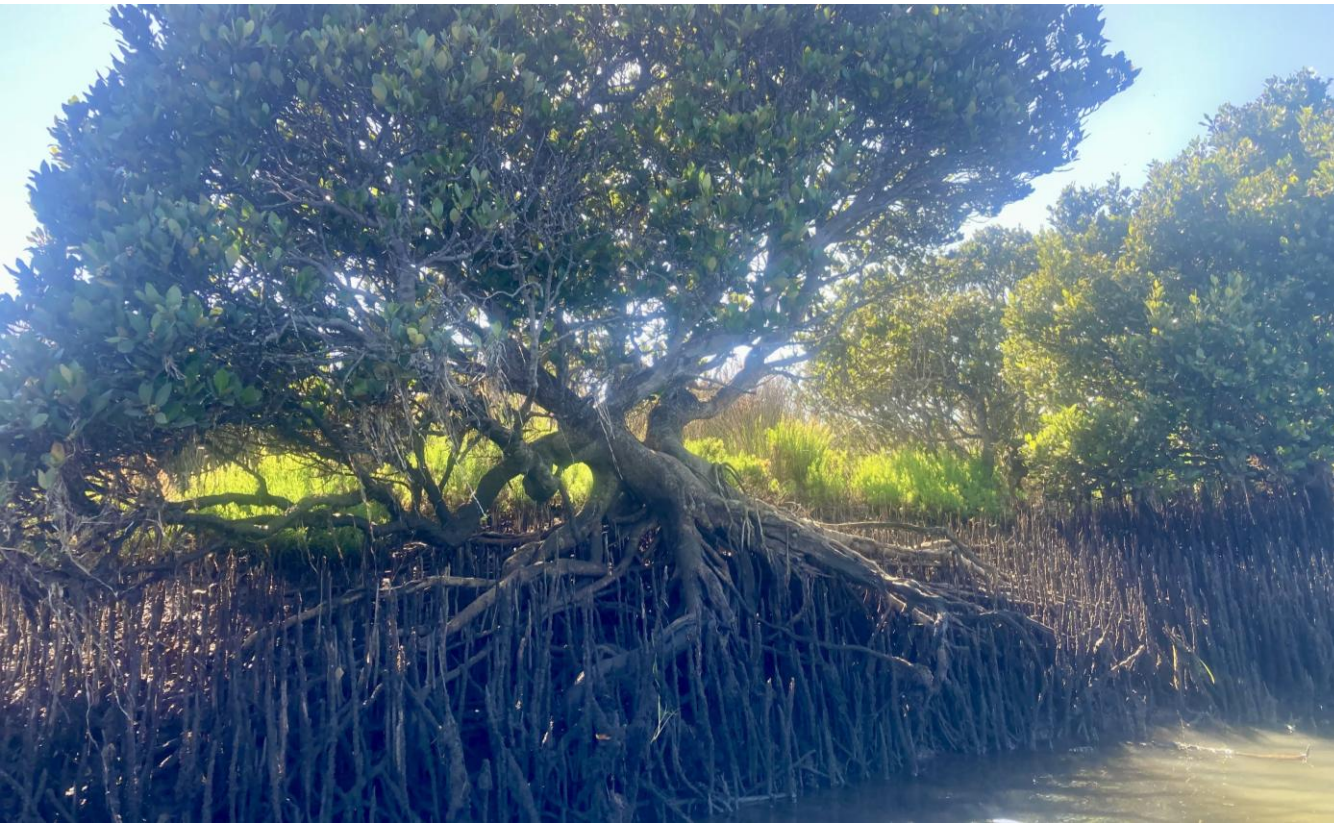
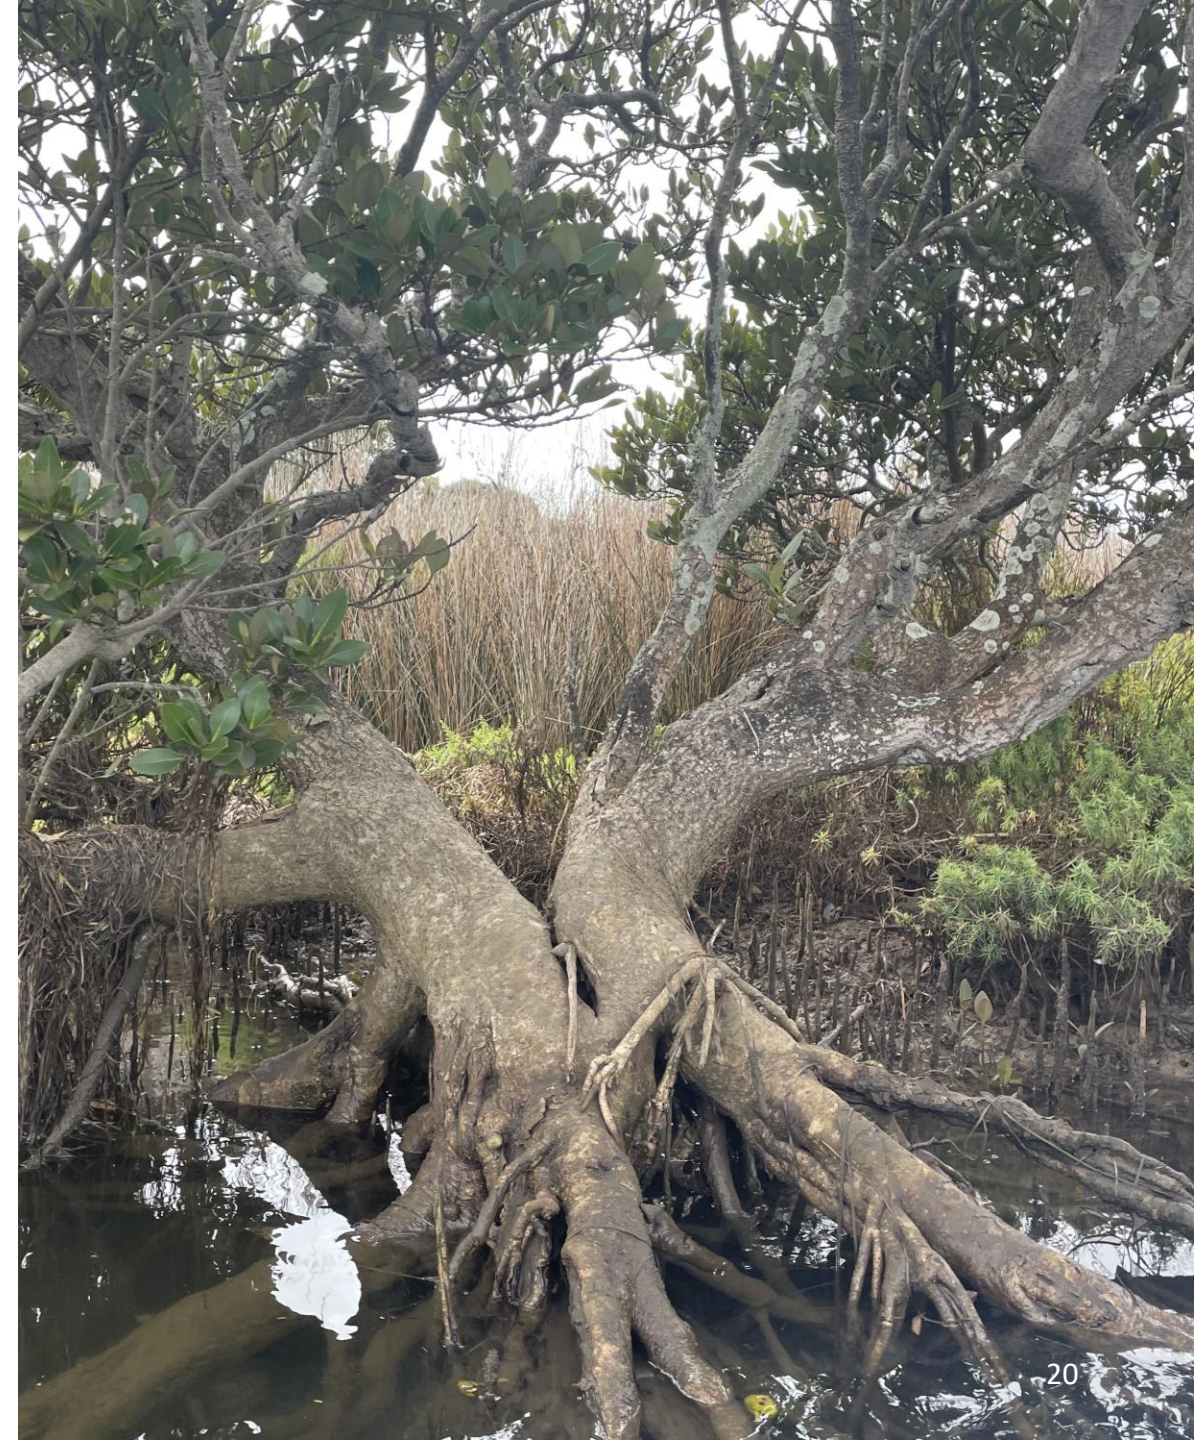
## Changes in Mangrove Health

The same mangrove photographed in 2021 (left) and 2026 (right). The later image shows extensive wax scale infestation, illustrating a marked change in the tree's condition over time.

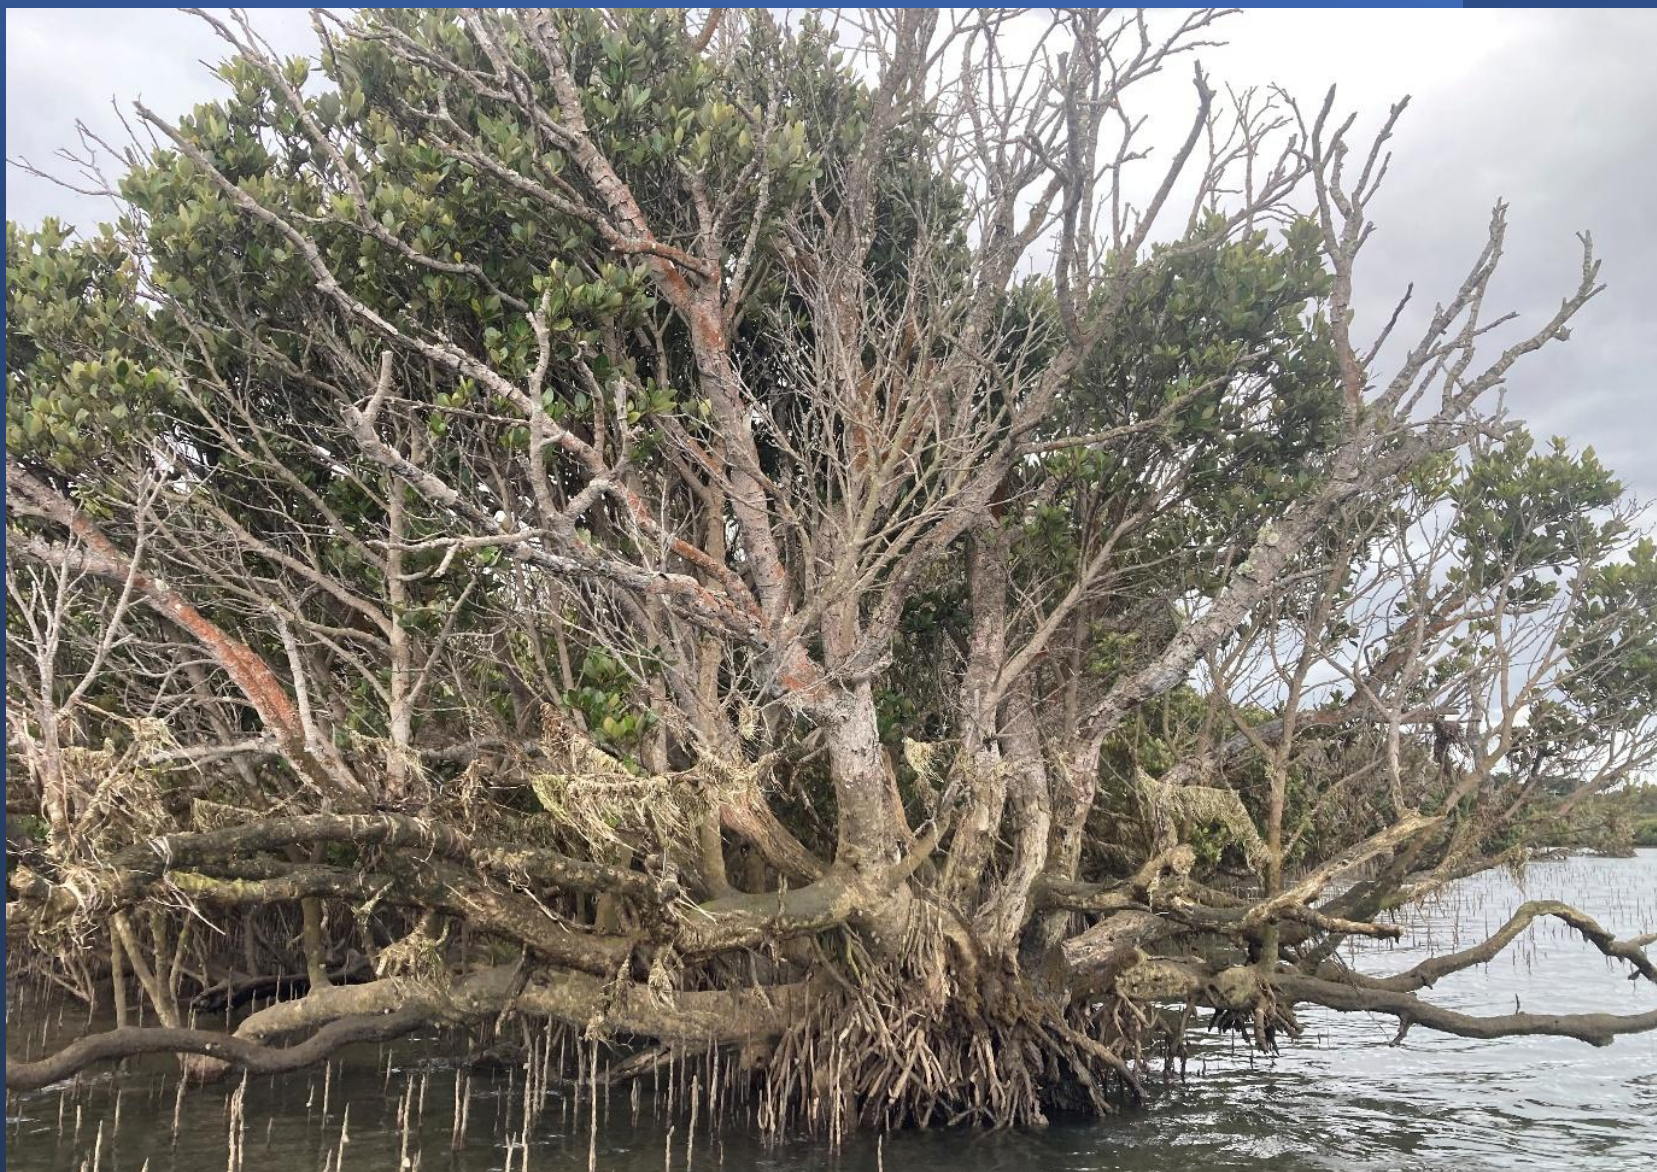
Repeated observations of declining and dead mangrove trees in and around the channel adjacent to the Ocean Grove Golf Club.

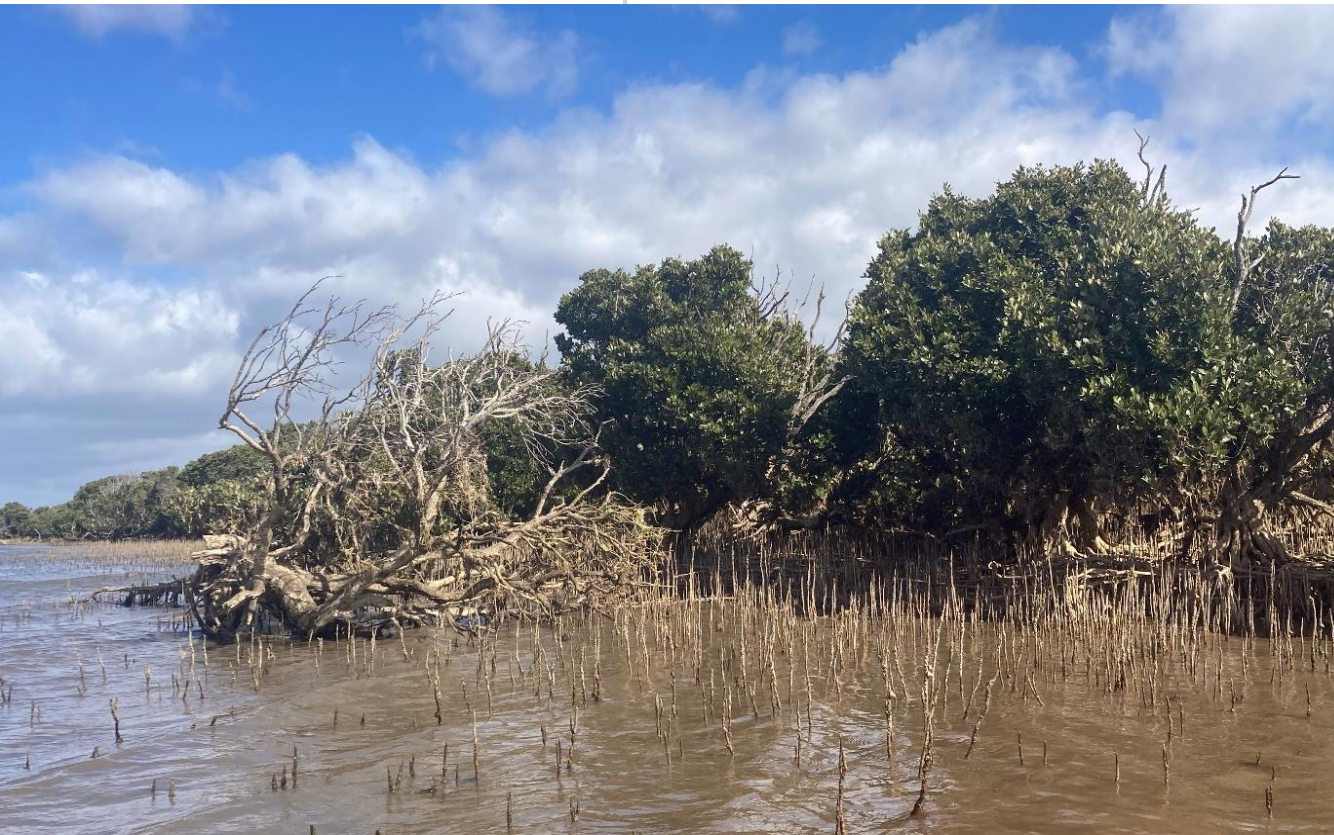
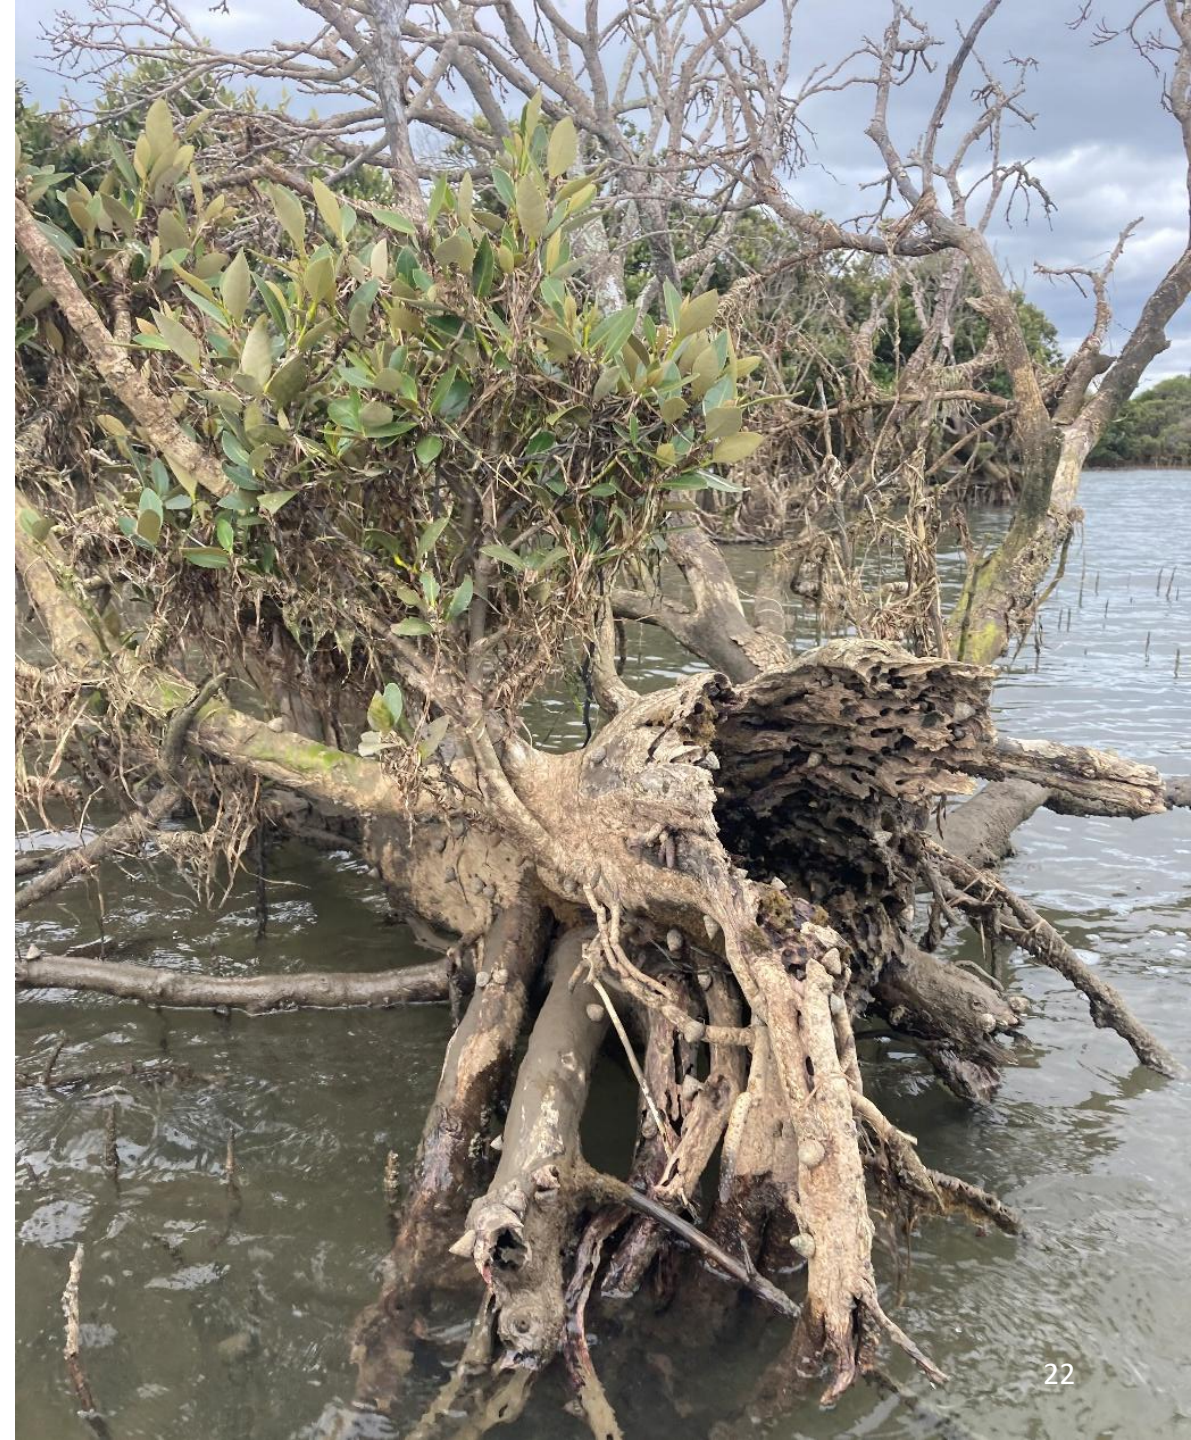
### **Algae on Mangrove Roots**

Algal growth observed on mangrove root systems in the Barwon Estuary, photographed on **19 July 2026**. Continued monitoring is recommended to better understand its extent and any implications for mangrove health.
