# Healthy Mangroves

# Calls for Action

# Long-Term Field Observations - Barwon Estuary (2019–2026)

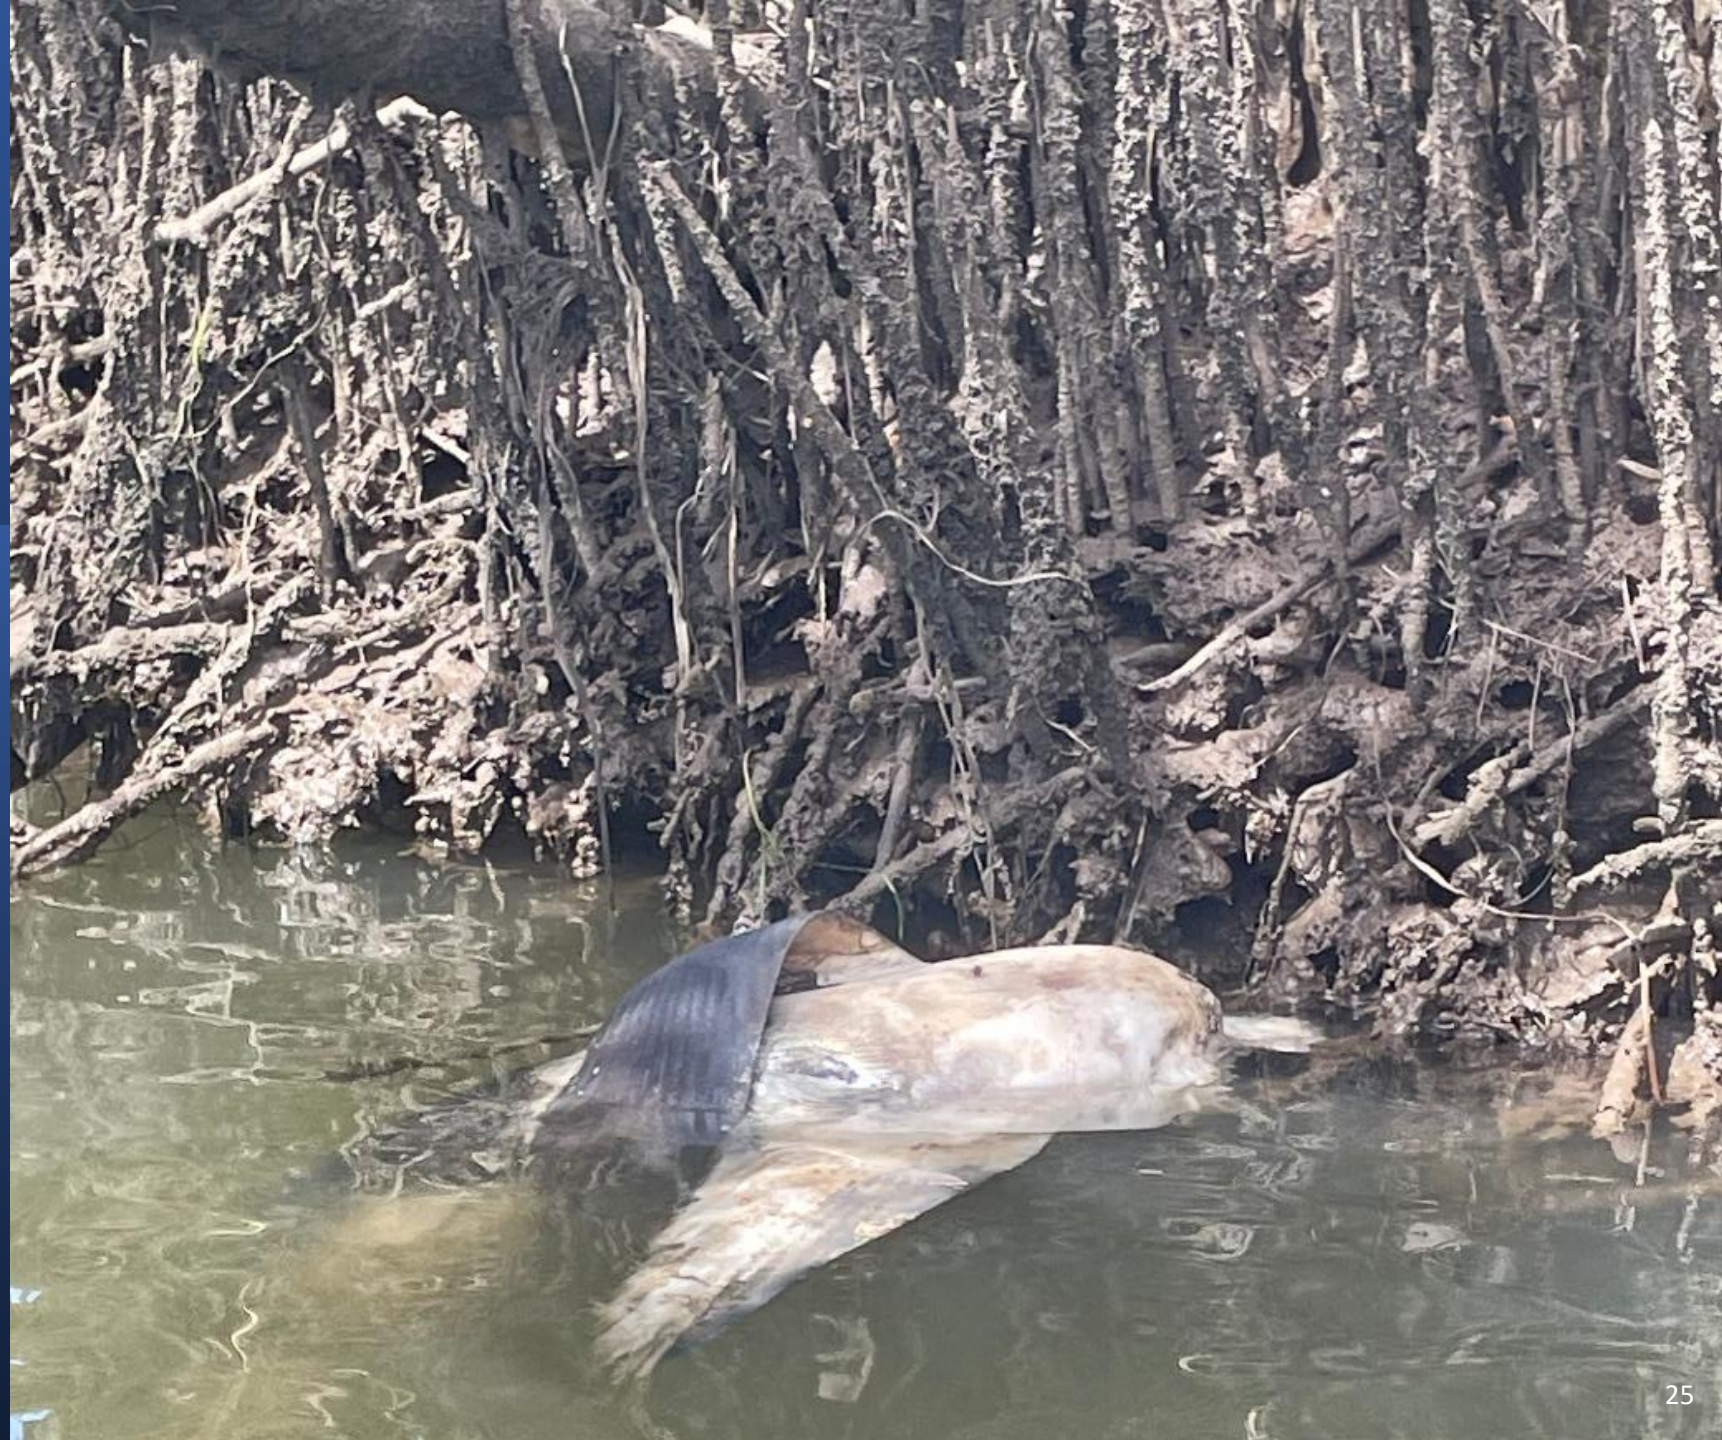
Elephant Fish migrate seasonally into the Barwon Estuary (February–May), using its soft-sediment habitat for egg laying.

Observation of a dead Elephant Fish, showing signs of a collision with a boat, among mangrove roots in the channel adjacent to the Ocean Grove Golf Club.
